Inspection Report for
Odd Fellow Sierra Recreation Association
Long Barn, CA

13 KG Steel on Grade
Tank #2

Date Completed: July 4th, 2010

Exterior Inspection Report

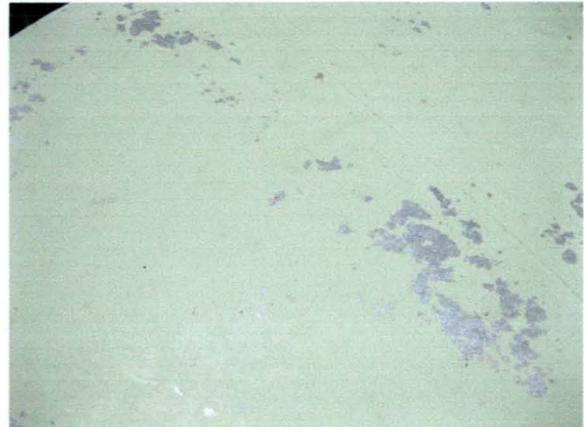
Roof Condition

Coating Condition: Fair/Poor
 Corrosion Present? Y N
 Percentage: N/A
 Seams/Welds Condition: Excellent
 Oxidation Present? Y N
 De-lamination Present? Y N
 Low Spots Present? Y N
 Holes in Roof? Y N
 Cathodic Protection Plates Present? Y N
 Sealed Edges: Y N NA
 Loose Plates? Y N NA
 Missing Plates? Y N NA

Summary: The roof was found in fair to poor condition with de-lamination noted. Recommend recoating the roof.

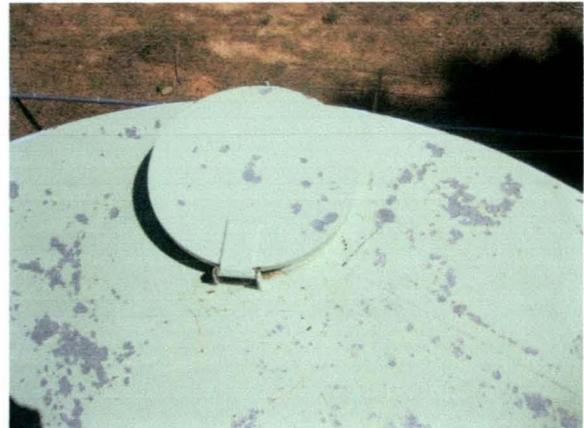
Access Hatch Condition

Coating Condition: Fair/Poor
 Corrosion Present: Y N
 Seams/Welds Condition: Excellent
 Oxidation Present? Y N
 De-lamination Present? Y N
 Hatch Size: 18 inch round
 Hatch Locked? Y N
 Hinge Condition: Good
 Gasket Present? Y N
 Intact? Y N NA
 Insects, dirt or debris present under hatch? Y N

Summary: The hatch was found locked with no gasket present and in good condition with corrosion and de-lamination noted. Recommend installing a gasket.

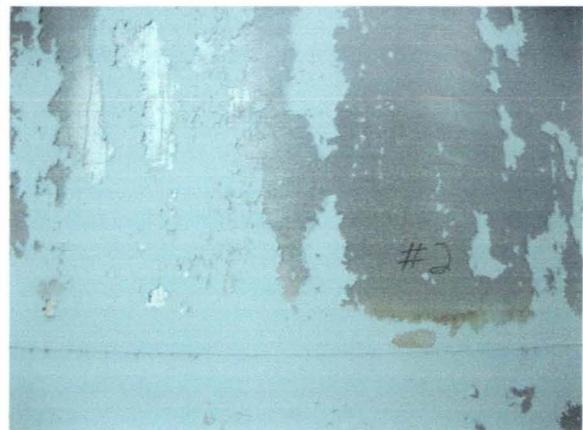
Wall Panel Condition

Coating Condition: Fair/Poor
 Corrosion Present? Y N
 Percentage: N/A
 Seams/Welds Condition: Excellent
 Oxidation Present? Y N
 De-lamination Present? Y N
 Dents Present? Y N
 Holes Present? Y N

Summary: The walls were found in fair to poor condition with 50% de-lamination noted. Recommend recoating.

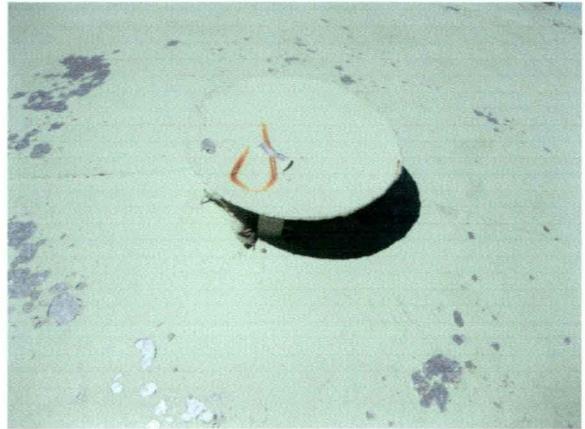
Vent Condition

Coating Condition: Good
Corrosion Present: Y N
Percentage: 5%
Seams/Welds Condition: Good
Oxidation Present? Y N
De-lamination Present? Y N

Screen in Place? Y N
Condition: Good
All Openings sealed? Y N
Cap Condition: Good

Summary: The vent was found in good condition with a screen in place and corrosion noted.

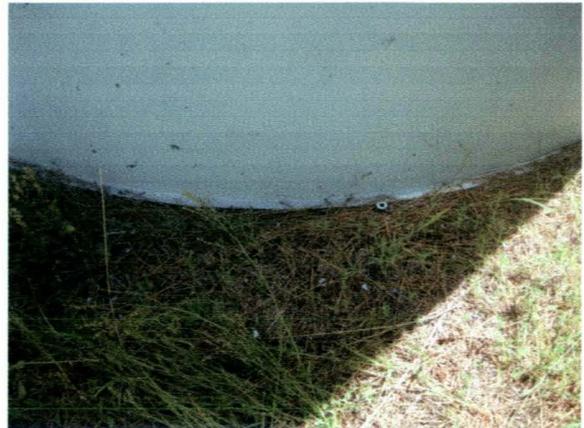
Foundation Condition

Foundation Exposed? Y N
Anchor Bolts Present? Y N
Corrosion on Anchor Bolts Present? Y N NA
Anchor Bolts Loose? Y N NA

Cracking Noted in Foundation? Y N NA
Spalling Noted? Y N NA

Summary: The foundation was found in excellent to good condition.

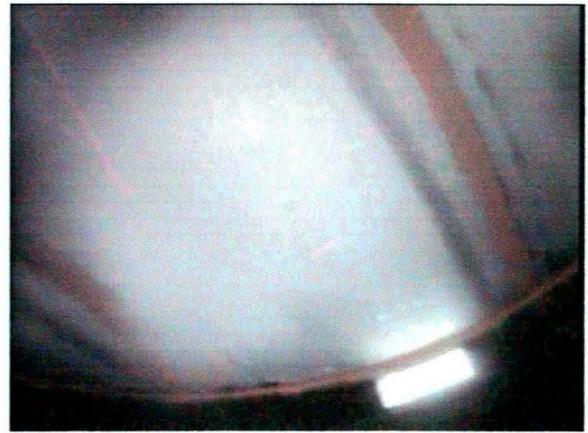
Roof Condition

Coating Condition: Good
Welds/seam condition: Good
Corrosion Present on panels? Y N
Percentage: N/A
Metal De-alloying noted? Y N
Percentage: N/A

Summary: The roof was found in good condition.
